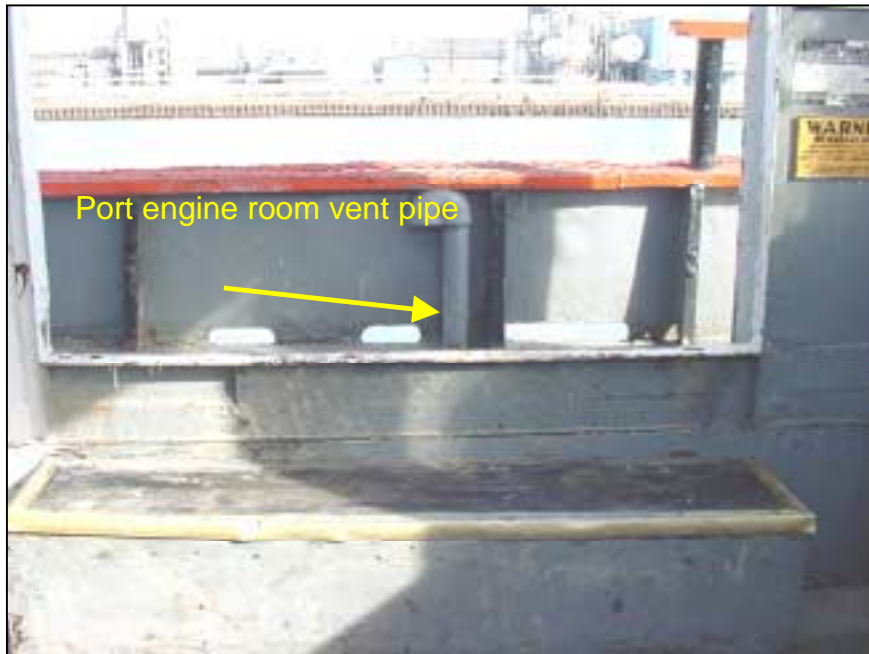
View of the port engine room vent pipe of the J. W. WESTCOTT II. This view is from inside the pilothouse, through the port side cargo door. Photo taken on November 8, 2001.

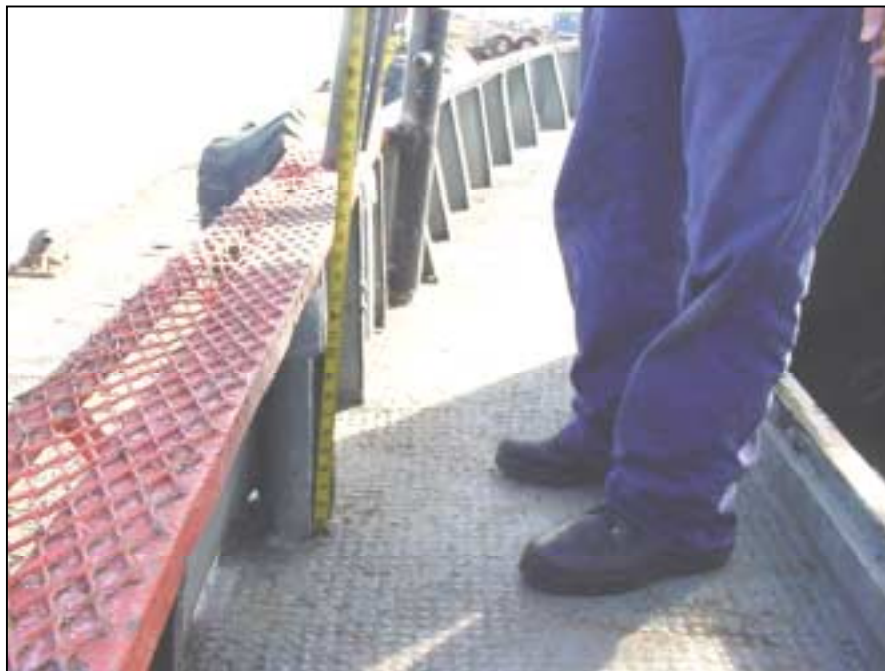
View of the port engine room vent pipe taken from port deck aft of cargo door. The vent pipe was 2" in diameter, 14.5 inches high, and situated on the outboard side of the engine room. Photo taken on November 8, 2001.

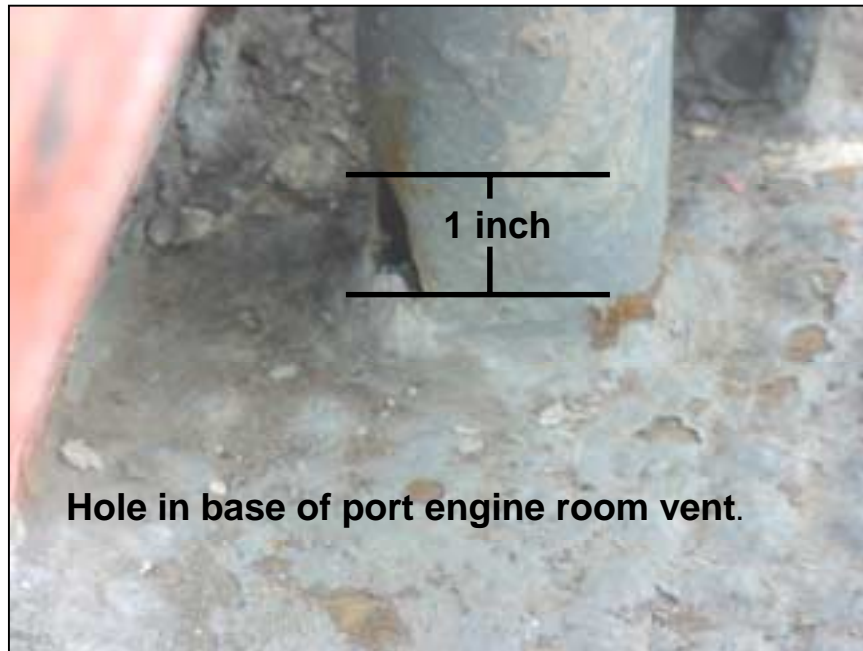
Close up view of the one inch hole found at the base of the port engine room vent pipe on the J. W. WESTCOTT II. The hole leads directly into the engine room. Photo taken on November 8, 2001.
